HOMER INSPECTION SERVICES

GENERAL HOME INSPECTION REPORT

1234 Main St. Downingtown Pa 19335

01/26/2021 9:00AM

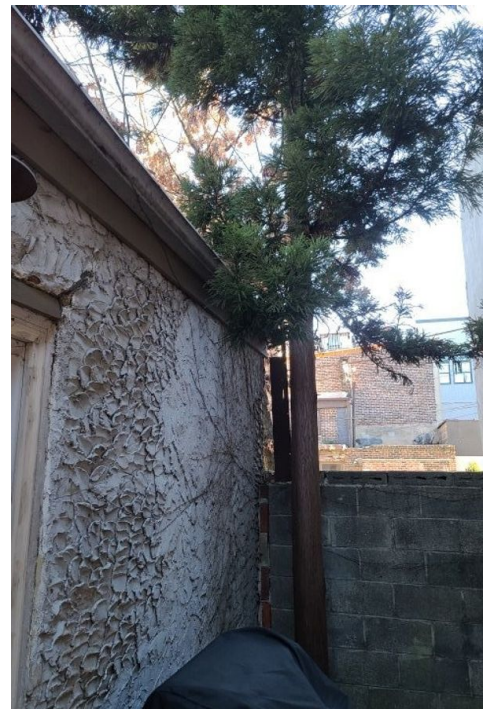
There are large tree(s) near the building foundation wall(s). The roots from trees may cause damage to the building foundation, and can also damage the building from falling branches. We recommend hiring a tree removal contractor to evaluate further.

Contact a qualified tree service company.

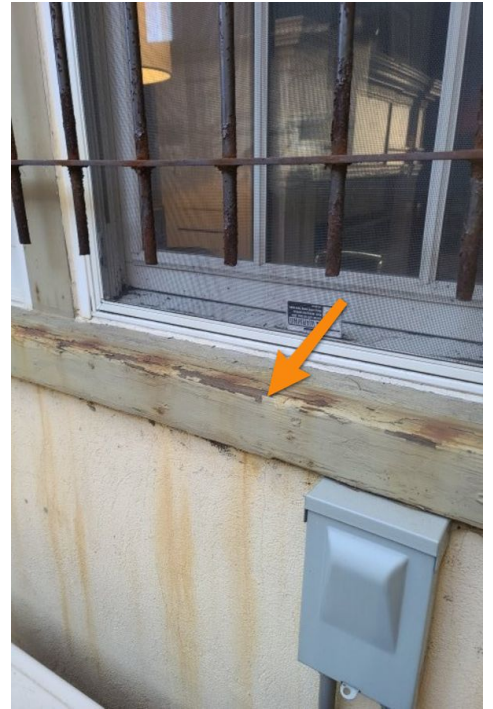
2.1.2 Wall Cladding

PEELING PAINT NOTED

There is peeling paint at wood trim. This will lead to further deterioration of the trim. Prepare and paint the trim where needed to maintain.

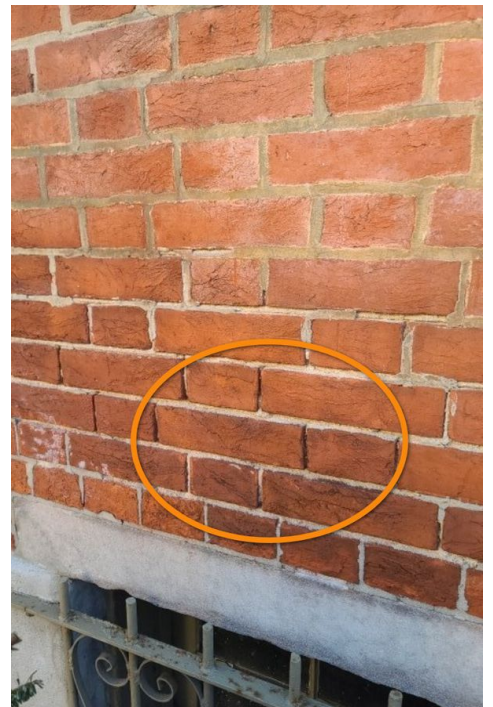
2.1.3 Wall Cladding

DETERIORATED MORTAR JOINTS

The mortar is missing or deteriorated in the mortar joints of the masonry wall(s). This will allow water infiltration and further deterioration. Contact a mason to evaluate and repair as needed.

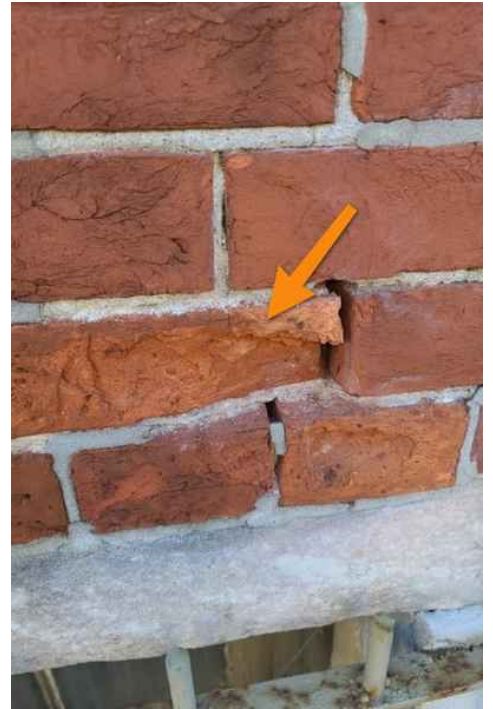
2.1.4 Wall Cladding

BRICK SPALLING NOTED

There are bricks with spalling or other deterioration. This is often due to water infiltration and/or freeze and thaw. We recommend contacting a mason to evaluate and repair or replace bricks as needed.

Contact a qualified masonry professional.

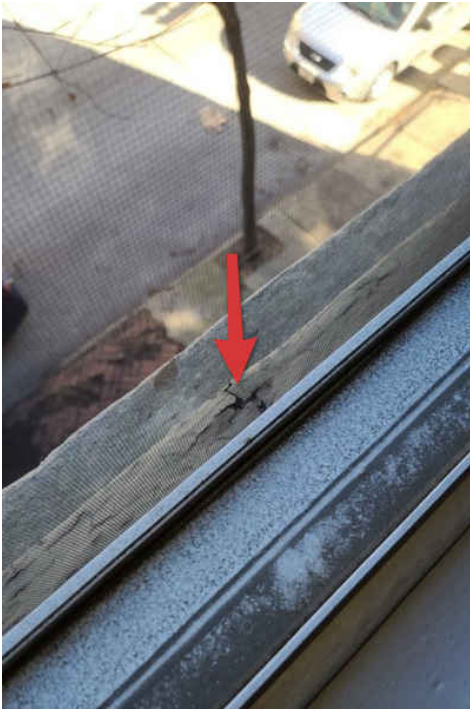
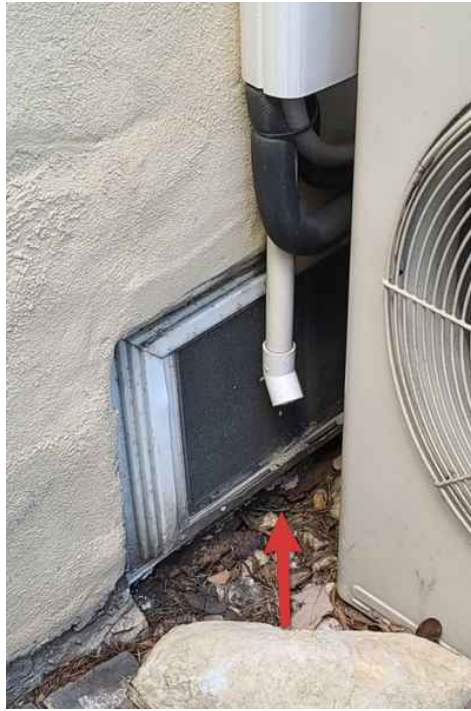
DETERIORATED TRIM

The exterior trim is deteriorated. Deteriorated trim may result in water infiltration and further deterioration. We recommend hiring a contractor to replace all damaged trim and any hidden damage that may be revealed.

Front Window

Basement Window

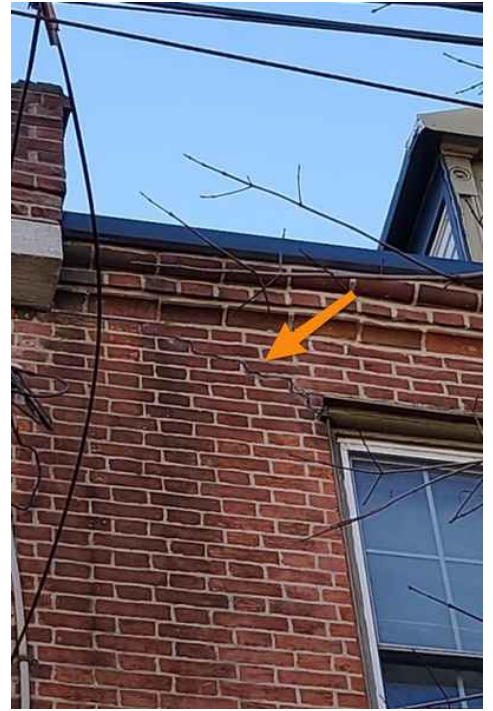
Front

MASONRY CRACKS NEAR LINTELS

There are cracks in the siding near steel lintels. This is often due the expansion and contraction of the steel lintels located above window/door openings that creates cracks or interruptions in the surrounding mortar joints. This may permit water entry. It may also be an indication that the lintels are in need of repair or replacement. We recommend hiring a mason to evaluate and make the necessary repairs.

Contact a qualified masonry professional.

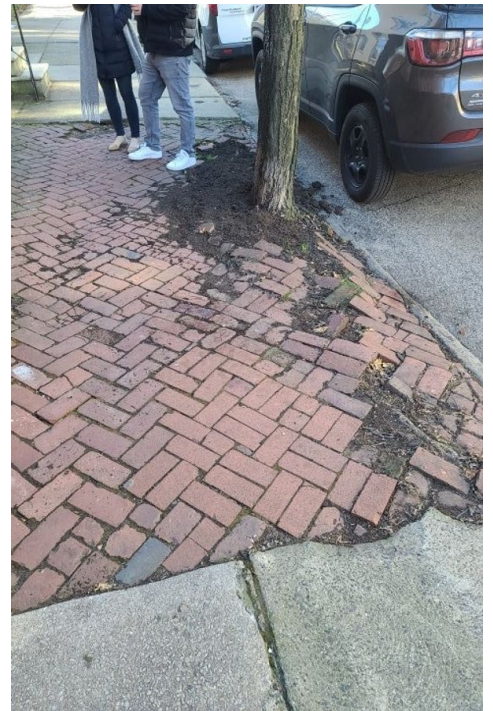
SETTLEMENT CAUSING TRIP HAZARD

There is settlement/heaving in the walkway. This has resulted in a trip hazard. Contact a contractor to repair or replace where needed for safety.

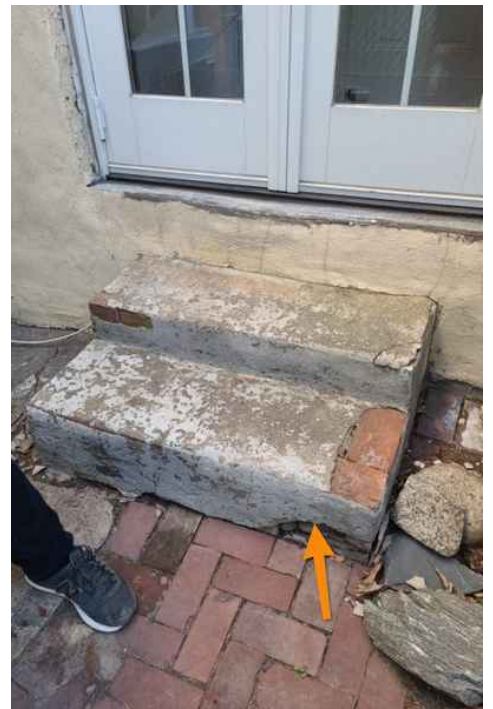
2.4.1 Stairs/Steps

DAMAGE

There are damaged or deteriorated steps. This will lead to water infiltration and further deterioration. We recommend hiring a contractor to make repairs.

Contact a qualified professional.

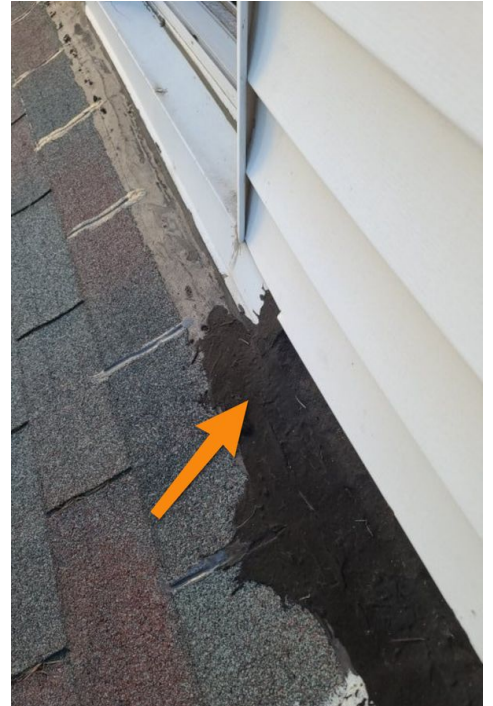
The flashings have been caulked or sealed using tar. Sealants are a temporary solution, and may also indicate past or periodic leaks. We recommend hiring a roofing contractor replace the flashings where needed to deter leaks.

Contact a qualified professional.

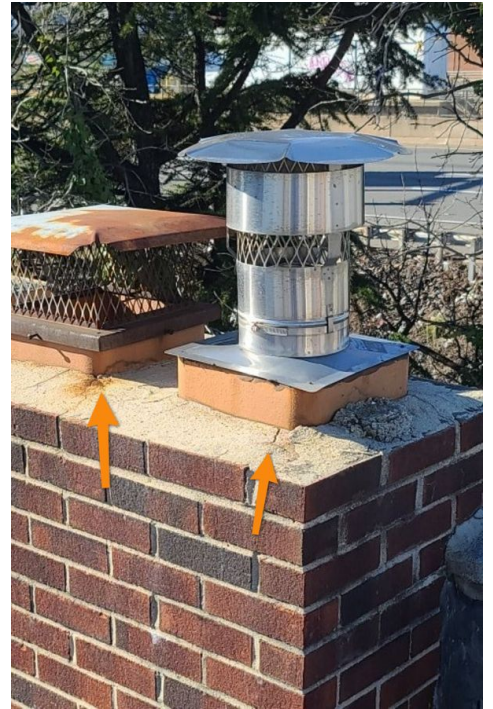
6.1.1 Chimney

Recommended Repair**CROWN CRACKED**

There are cracks in the concrete chimney crown. We recommend sealing all cracks to deter water entry and further deterioration.

Contact a qualified chimney contractor.

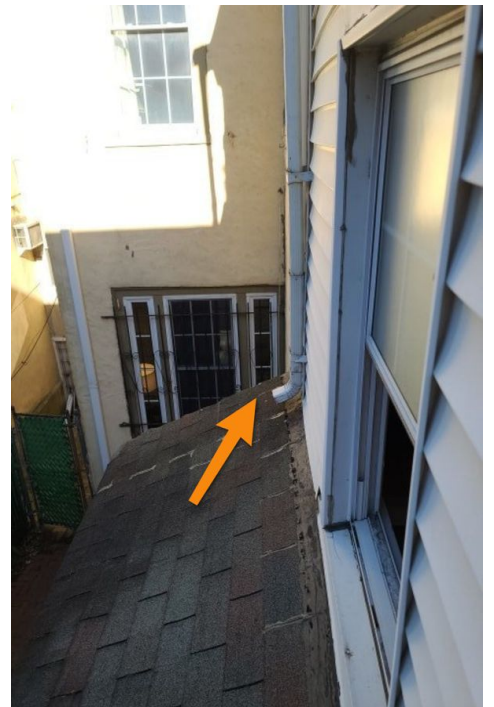
7.1.2 Gutters/Downspouts

Recommended Repair**ROOF DISCHARGE**

There are downspouts discharging onto the roof covering. This will cause premature wear of the roof covering and may result in leaks. Extend the downspouts to discharge into the lower gutters.

Contact a qualified roofing professional.

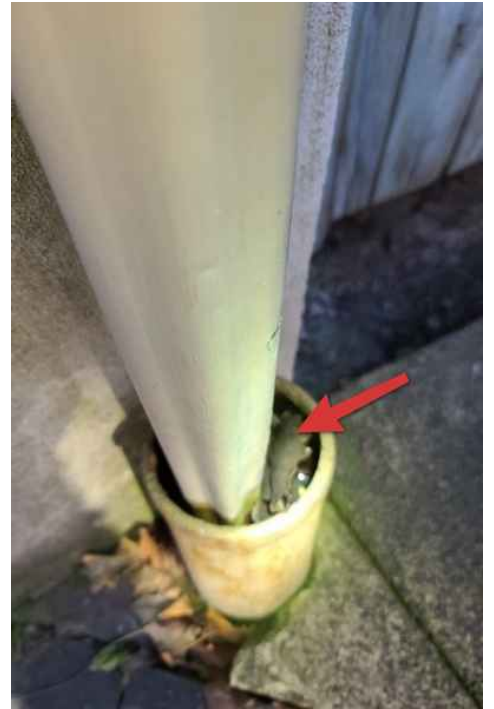
7.1.3 Gutters/Downspouts

CLOGGED LATERAL

The downspout lateral appears to be clogged or obstructed. This will result in roof drainage discharging onto the surface, which may lead to basement dampness or water infiltration. We recommend hiring a plumber or other qualified contractor to assess the condition of the underground drainage system and make repairs as needed to promote proper drainage.

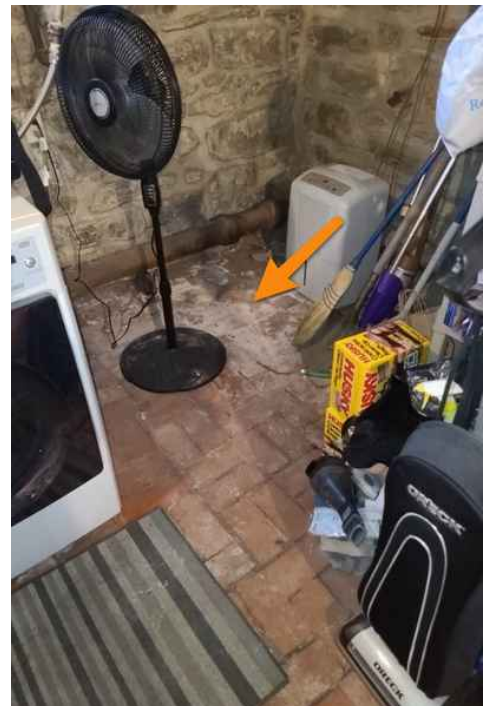
8.1.1 Foundation

**Recommended Repair****PAST WATER ENTRY NOTED**

Evidence of previous water penetration was observed in the basement. No indications of recent water penetration were observed. See notes in the report concerning water control for recommendations to deter basement dampness. Under some weather conditions, water penetration may still occur. Proper grading and proper management of site and roof drainage should reduce the chance of future water penetration. The observed evidence of previous water penetration may relate to a singular previous occurrence or to a source of water penetration which has been corrected. We recommend consultation with the current owners regarding the history of the issue.

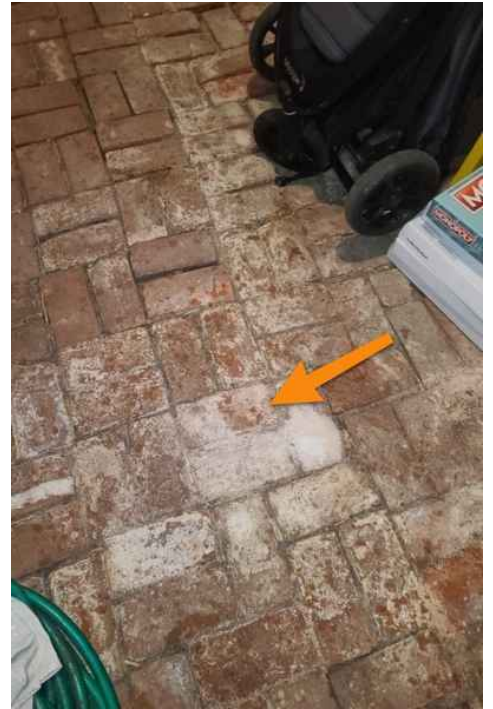
8.1.2 Foundation

Recommended Repair**EFFLORESCENCE NOTED**

There is efflorescence on the foundation wall(s) and basement floor. Efflorescence (which means "to flower out" in French) is the dissolved salts deposited on the surface of a porous material (such as concrete or brick) that are visible after the evaporation of the water in which it was transported. The moisture that creates efflorescence often comes from groundwater, but rainwater can also be the source. Efflorescence alone does not pose a major problem, but it can be an indication of moisture intrusion, which may compromise the structural material. See notes in the report concerning water control, structure, etc..

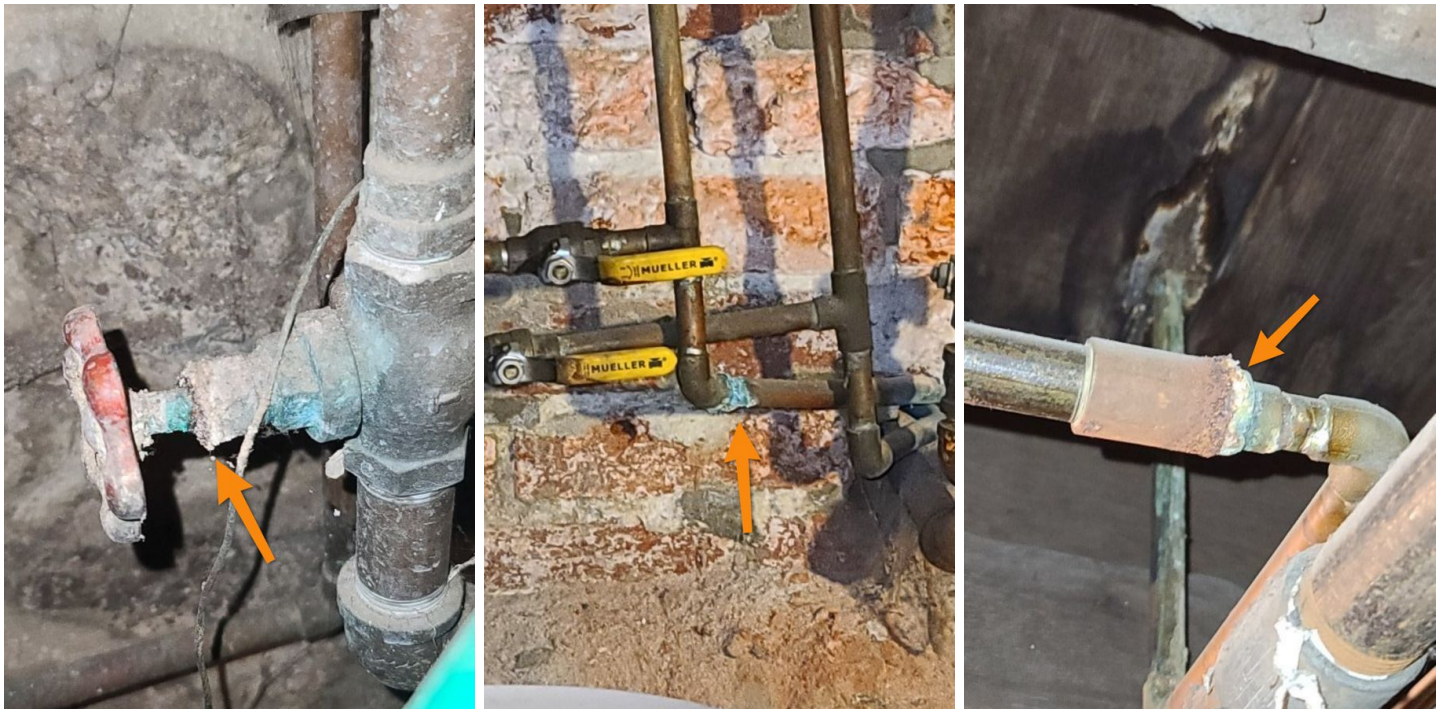
CORROSION/BENIGN LEAKS NOTED

There is corrosion or evidence of benign leaks at water supply pipes. Hire a plumber to evaluate and service/replace pipes where needed.

Contact a qualified plumbing contractor.

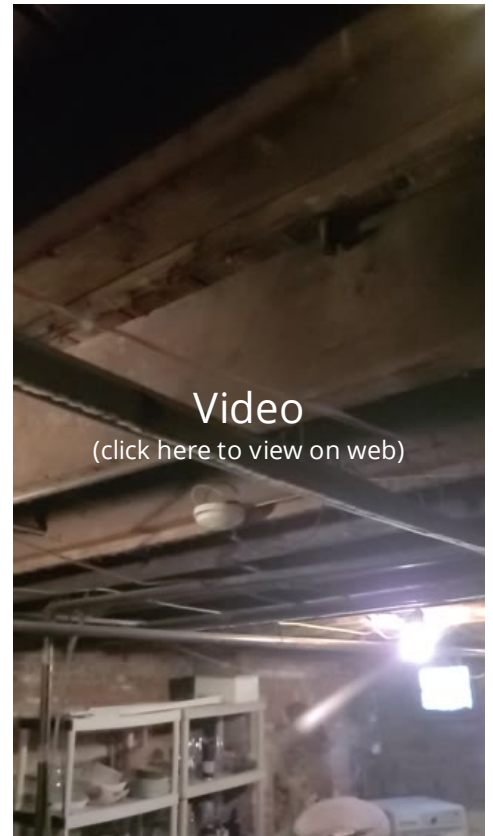
9.2.2 Distribution Pipes

Recommended Repair**PIPE SUPPORT NEEDED**

There are water supply pipes that are not adequately supported. The lack of support can damage the pipes and result in damage and/or leaking. We recommend contacting a plumber to evaluate and support the pipes where necessary.

Contact a qualified plumbing contractor.

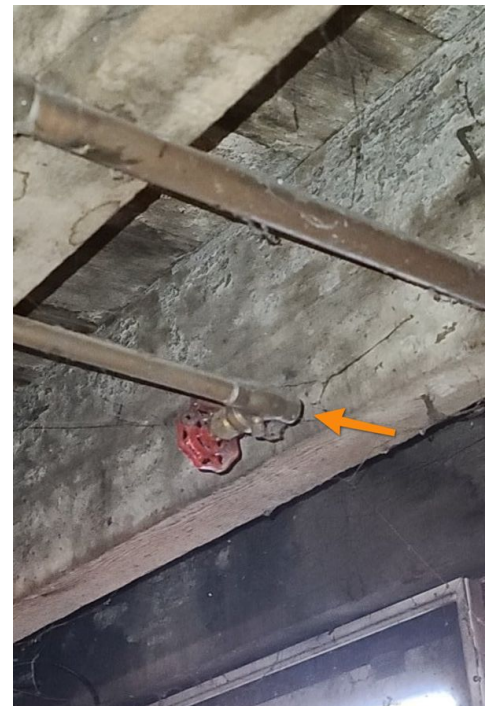
9.2.3 Distribution Pipes

Recommended Repair**OPEN-END PIPE**

There are open-end water supply pipe(s). This may result in leaking. Hire a plumber to properly terminate pipes to deter leaks.

Contact a qualified plumbing contractor.

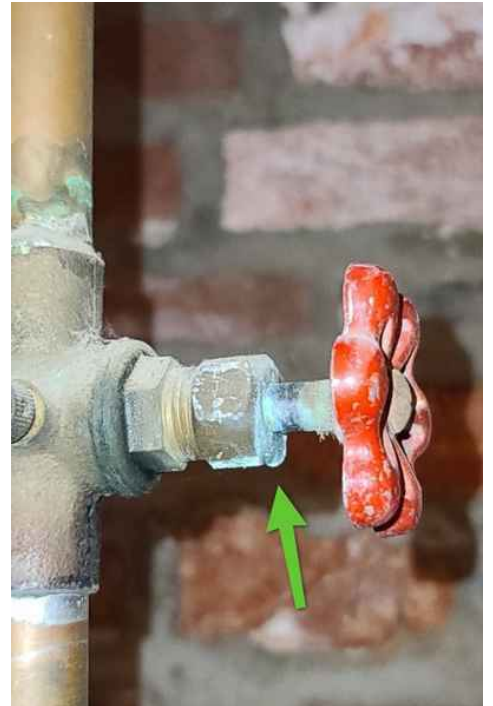
LEAK NOTED

There is a leak at a water supply pipe/valve. Leaks will waste water and can cause water damage. We recommend shutting off water supply to the affected area(s), and contacting a plumber to evaluate and make repairs.

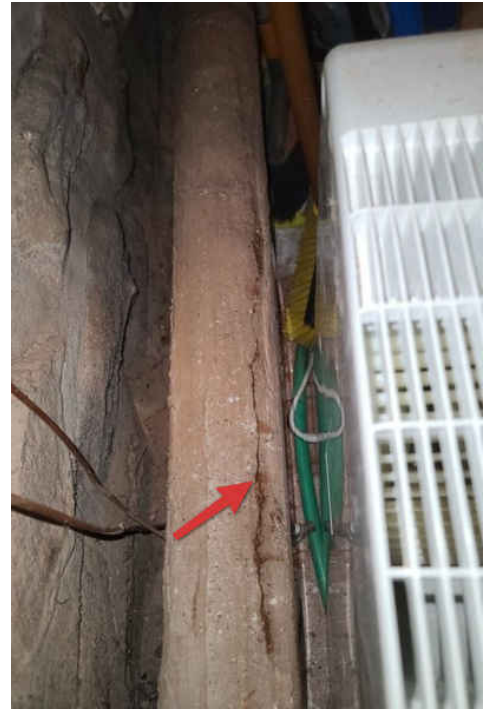
Cracked Pipe

PIPE DAMAGED/DETERIORATED

The drain/waste pipe(s) are damaged or deteriorated adjacent to the electrical panel. There is a large crack with evidence of seepage. This may result in water damage, and is potential health hazard. Hire a plumber to evaluate and replace the pipes where necessary.

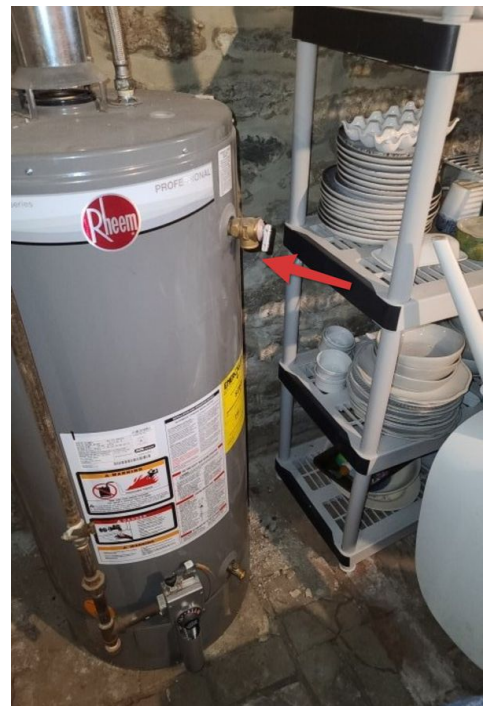
10.1.1 Water Heater

TPRV DISCHARGE PIPE MISSING

The water heater's TPRV discharge pipe is missing. This is a safety hazard. Contact a plumber to install an approved discharge pipe.

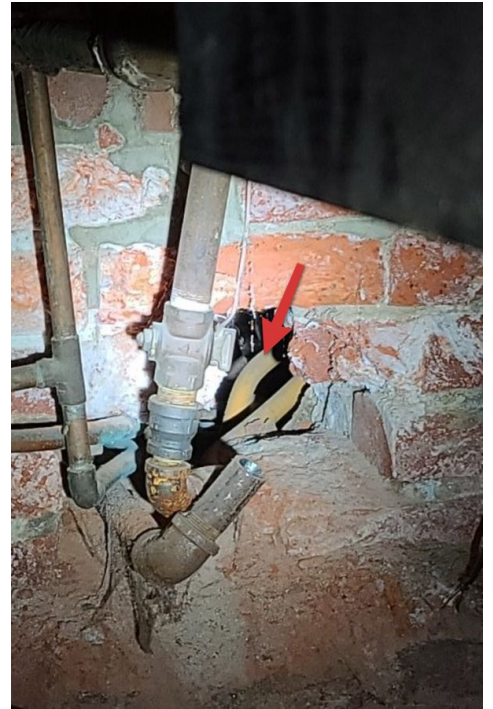
The gas system includes CSST (corrugate stainless steel tubing). CSST is a known safety hazard if not properly bonded to the grounding electrode system to protect it from damage caused by lightning strikes. We recommend contacting an electrician to evaluate and repair the system.

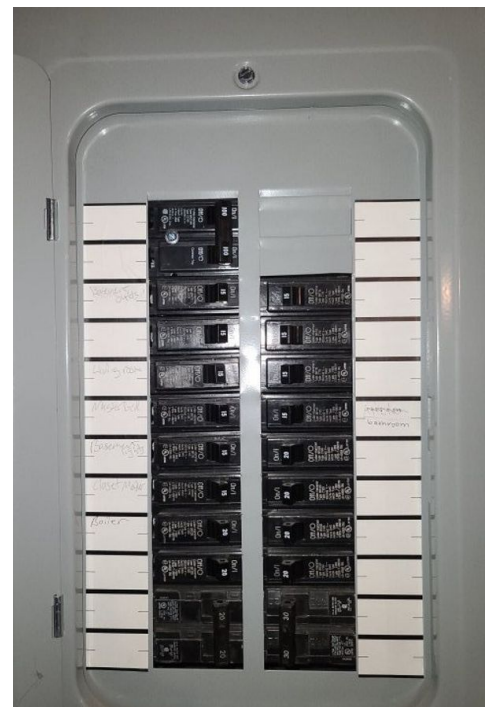
MISSING BREAKER LABELS

The service panel circuit breakers are missing labels. All circuits should be properly labeled for safety. Contact an electrician to label all circuits.

Contact a qualified electrical contractor.

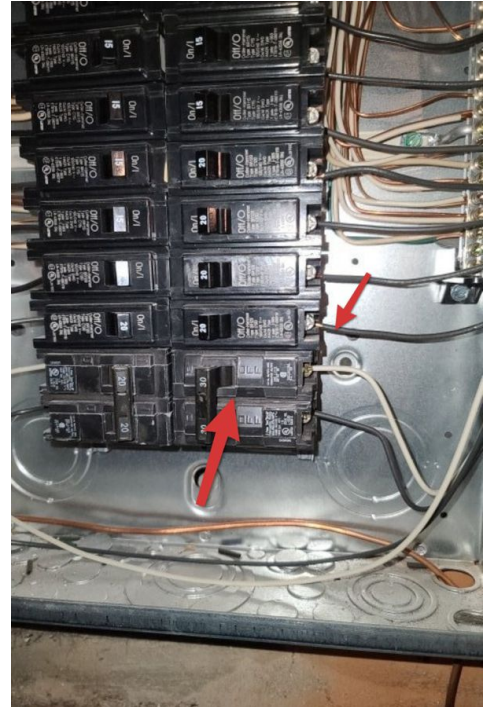
There are oversized breaker(s) in the service panel. There are 12-gauge conductors protected by a 30 amp circuit breaker, where a 20 amp circuit breaker should be used. This is a safety hazard as it may not trip when needed. Contact an electrician to evaluate the service panel and make repairs as needed.

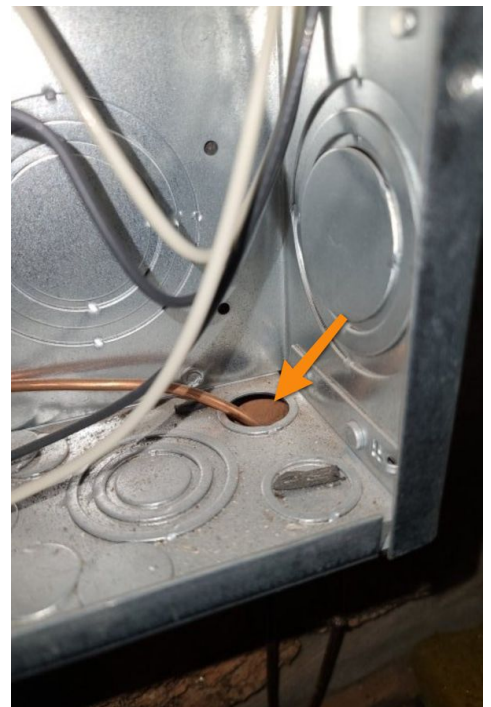
12.3.4 Service Panel

IMPROPER KNOCKOUT USED

The improper knockout was used to run the grounding electrode conductor. The open space in the panel creates an avenue for rodents to enter. We recommend relocating the grounding electrode conductor using the proper knockout, and using a knockout cover to seal the opening.

Contact a qualified electrical contractor.

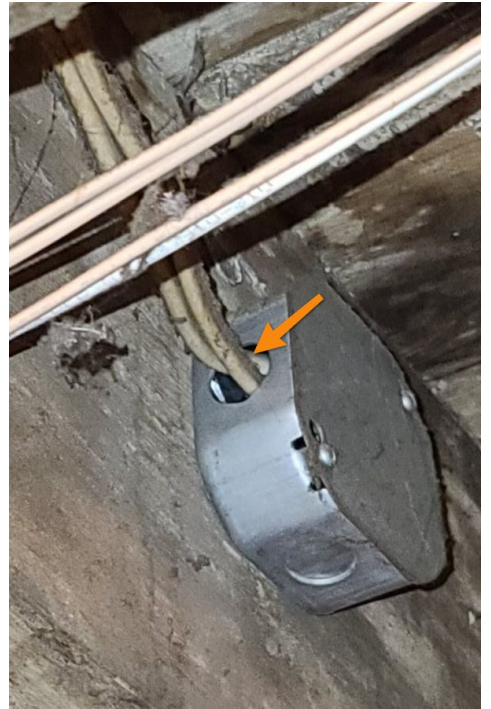
12.4.1 Branch Wiring

MISSING CONNECTORS

There are junction boxes with missing wire connectors. This may result in damage to the wiring. This is a safety hazard. Contact an electrician to install wire connectors where missing.

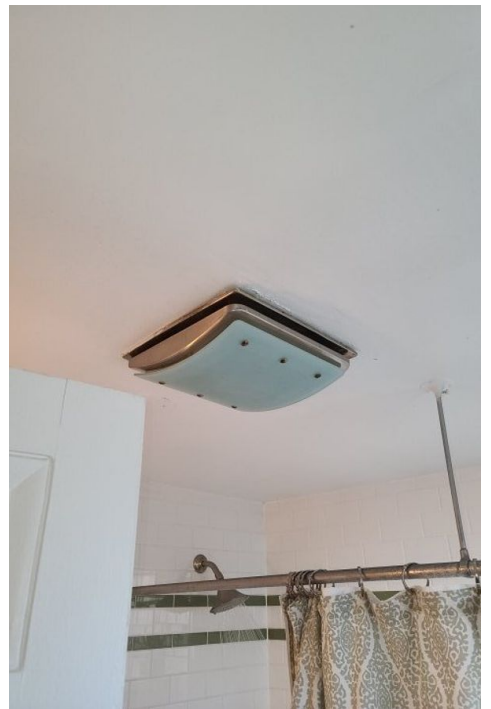
12.5.1 Fixtures/Switches

INOPERATIVE LIGHT

The light fixture(s) is inoperative. This may be due to expired light bulbs. We recommend replacing the light bulbs to verify the fixture is operative. Contact an electrician for further evaluation if necessary.
